Food safety in cassava “flour houses” of Copioba Valley, Bahia, Brazil: Diagnosis and contribution to geographical indication[☆]

An exploratory and quantitative study was performed with cassava flour producers from Copioba Valley, Bahia, Brazil. Fieldwork was conducted from November 2012 to February 2014 as part of the project entitled “Quality, identity and notoriety of cassava flour of Nazaré das Farinhas, Bahia: a contribution to Geographical Indication”.

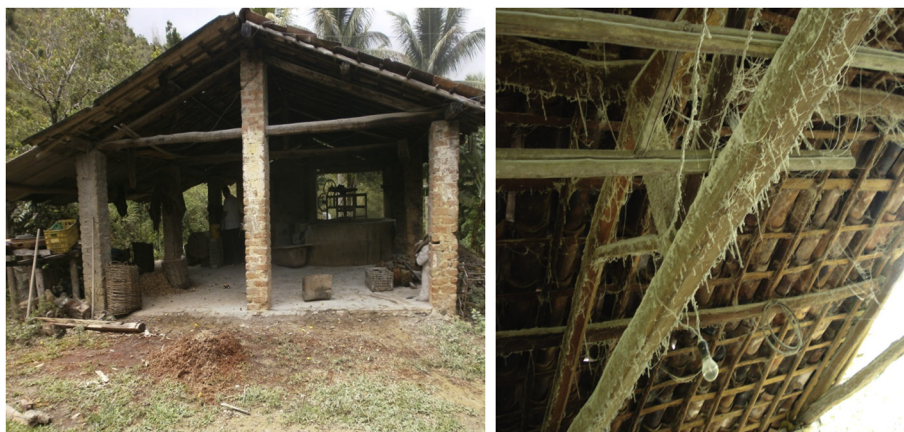
Based on visits to the flour houses, it became clear that many had a precarious infrastructure. In most cases (70%), the floors were pure earthen soil; in other cases, the floors were composed of a mixture of cement and compacted earthen soil (20%) or cement alone (10%). The ceilings (roofs) of the flour houses were also in

Fig. 1. Facilities of cassava flour houses in Copioba Valley, Bahia, 2012–2013.

poor condition because the covers were made with clay tiles supported by wood rafters and laths that were unlined. These structures, while affording some product protection, did not favor cleaning, leaving food products susceptible to contamination.

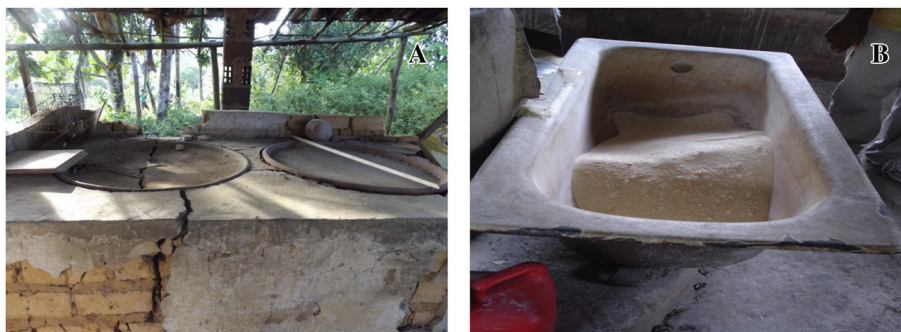
Establishments were characterized by rustic equipment and utensils because most were manufactured with wood, a material that makes cleaning difficult ([Fig. 2](#)). Following rural traditions, wood was also used to manufacture troughs, bowls, shovels for the mechanized system and/or for the manual system, and squeegees for turning flour, among other items. [Freitas, Farias and Vilpoux \(2011\)](#) notes that this practice risks food contamination once utensils are exposed to dirt and also attracts pests that favor physical and biological contamination. Evaluating the production safety of “Fufu”, [Obadina, Oyewole, Sanni, Tomlins, and Westby \(2010\)](#) observed similar rustic characteristics in flour production units.

Fig. 2. Hardiness and conservation status of equipment used in the production of Copioba flour (A) and the reuse of domestic installations for flour production (B). Copioba Valley, Bahia Brazil, 2013.

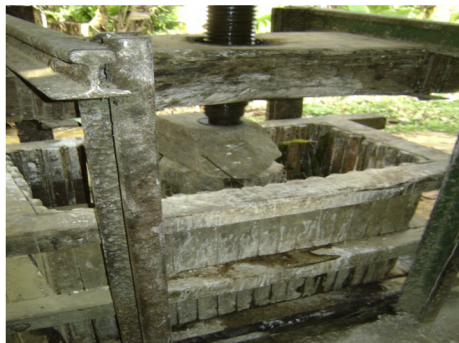
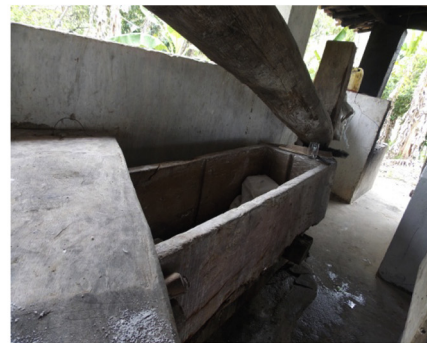
In 75% of the surveyed flour houses, craft presses made of wood, with a rotating screw system and hydraulic jack ([Fig. 3](#)), were used; for 25% of producers, the process was performed in hydraulic presses. For pressing, both in modern and ancient systems, the cassava mass was placed in raffia bags and could remain there for 2–24 h. [Sant’anna and Miranda \(2004\)](#) noted that this is one of several unsafe steps in terms of food quality because the food is subject to various forms of contamination because the raffia bags are recycled and often do not undergo cleaning.

Fig. 3. Models of artisanal presses used in Copioba Valley, Bahia, Brazil, 2013.

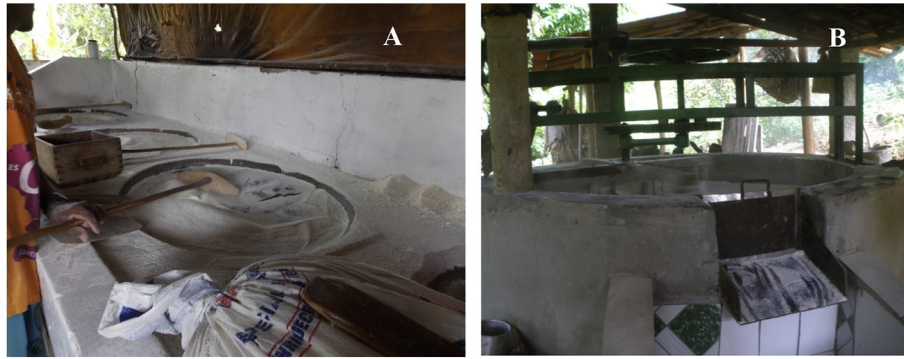
machines used. In most cases (77.8%), the furnaces were characterized by a brick structure with mud and/or cement and had an iron plate on which the flour was blended by a set of blades in planetary motion. These blades operated through a combustion engine or electric motor that comprised a mechanical system; alternatively, squeegees or wooden paddles were used in a manual system (22.2%). However, in the flour mills visited, regardless of the adopted roasting system, no cleaning schemes or preventative maintenance practices were used to ensure the operation of the furnaces.

In Copioba Valley, most flour houses (87.8%) had a single oven and were largely (94.5%) powered by motors, whereas the remaining (5.5%) operated with manual work. However, there were some flour houses that performed roasting via ancient methods, using three furnaces (Fig. 4). The three furnaces had different temperatures with different functions: the first, with an average temperature of 75 °C, induced the process of partial dehydration, popularly known as “zanzar”; the second, at a slightly higher temperature (average of 95 °C), caused complete dehydration, a process known as “grolhar”; and the third and final oven, with a temperature of 125 °C, performed the final roasting of the flour, a function known simply as “toasting” (Lody, 2013).

Fig. 4. Roasting systems with a manual furnace (A) and with a motor (B) in Copioba Valley, Bahia, Brazil, 2013.
